Dowagiac River Restoration

Final Assessment Report

June 27, 2013

**DOWAGIAC RIVER ASSESSMENT
FINAL REPORT**

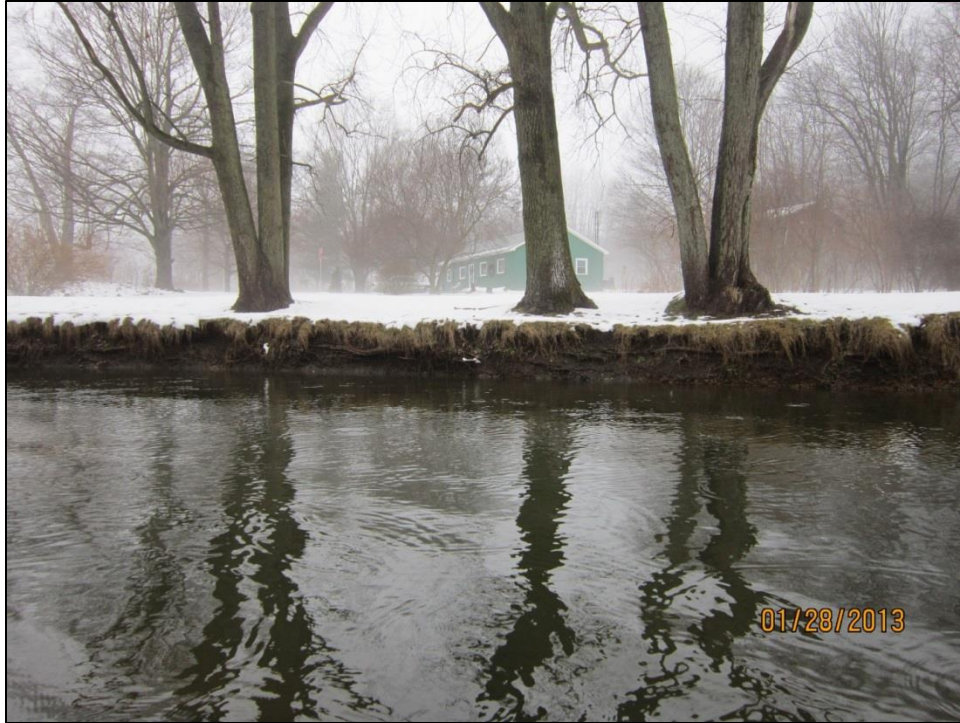
Figure 2. This house upstream of Peavine St. is sited very near the Dowagiac floodplain

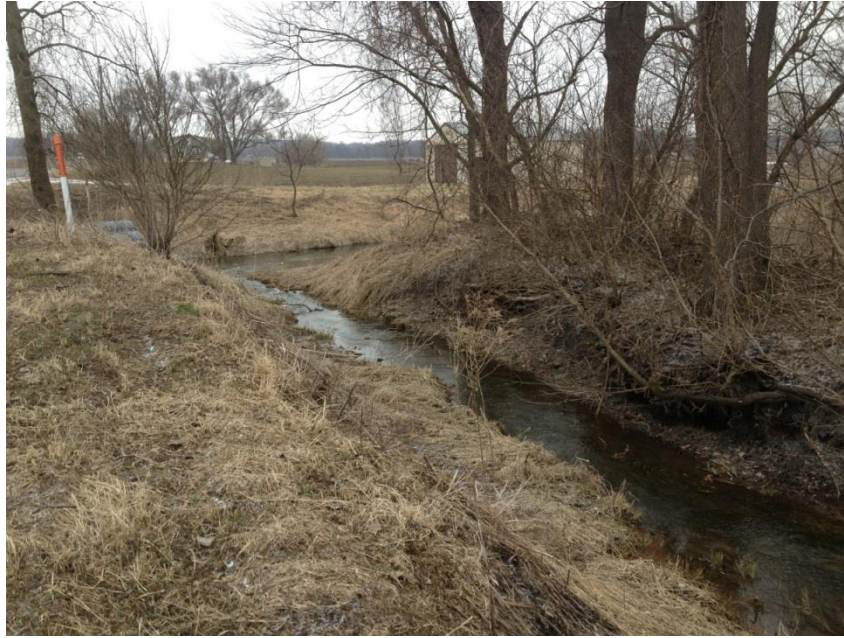
At Old Swamp Rd., Near Decatur – A small tributary enters along the road showing some signs of erosion, the channel is extremely low gradient with little capacity to transport sediment that gets into the channel. This location is just below Pickeral Lake, noted as the area where the historic dredging project occurred.

Figure 13: Tributary showing some erosion and sediment delivery to the Dowagiac River

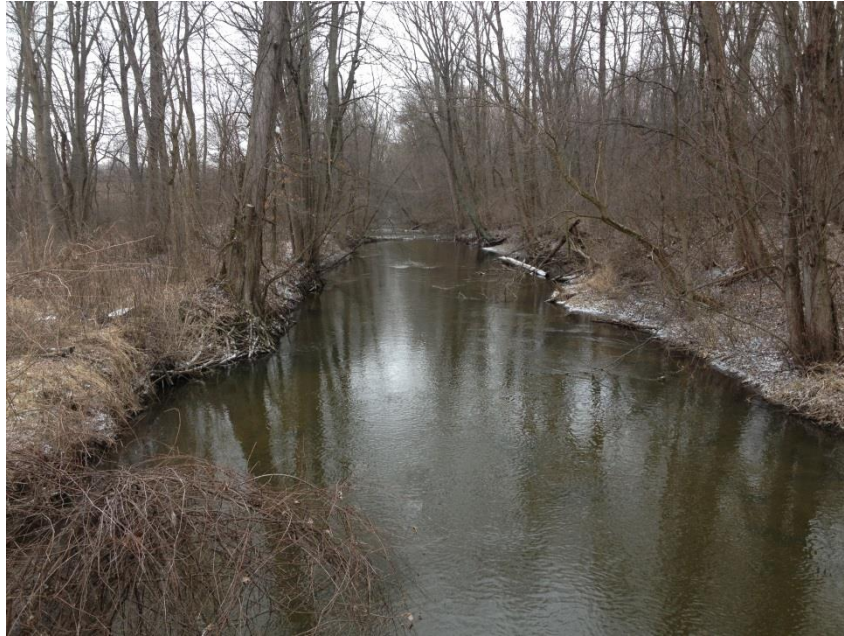
At Rudy Rd. – The river here begins to take the form noted within the project area with significant spoils piles on each side of the straight channel. Trees along the banks are leaning slightly and some exposed roots are evident, indicating some erosion is occurring but at very slow rates. The bed is composed of sands and fines here and some deposition is apparent in the photo below on the right bank.

Figure 20: Dowagiac River at Rudy Rd.

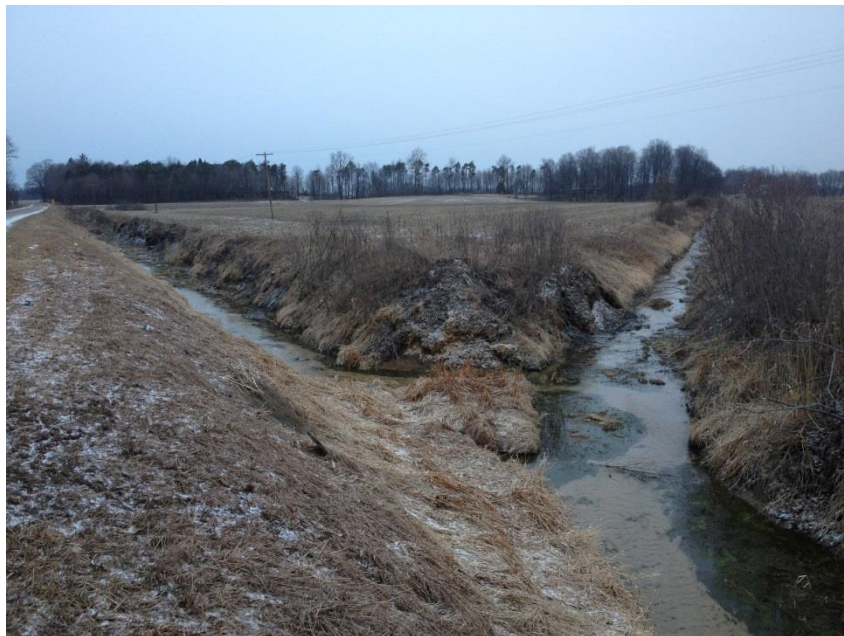
Figure 22: A small tributary along Middle Crossing Rd., just west of the Dowagiac. Sand is present in the channel and during runoff events, it is likely topsoil is being mobilized into the channel as well given the lack of buffer

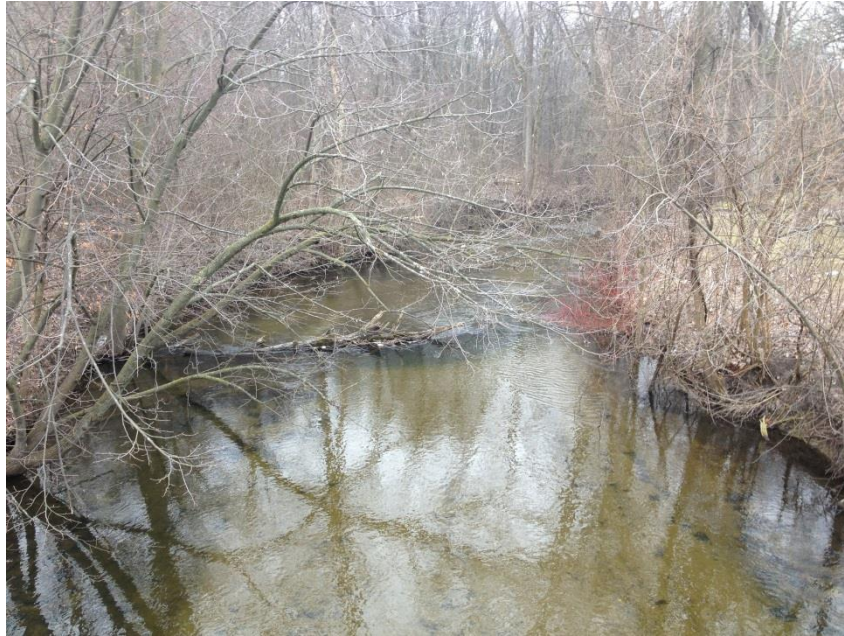
At M-62 – Very similar to upstream sections and to our project area. This is the last stop prior to the confluence with Dowagiac Creek, one of the larger tributaries to the Dowagiac. The creek includes a mill dam that arrests most sediment delivery its upper watershed before it can get to the mainstem Dowagiac. Sand is noted in the bed.

Figure 23: Dowagiac Creek at M-62. The sand bed is prevalent in the photo

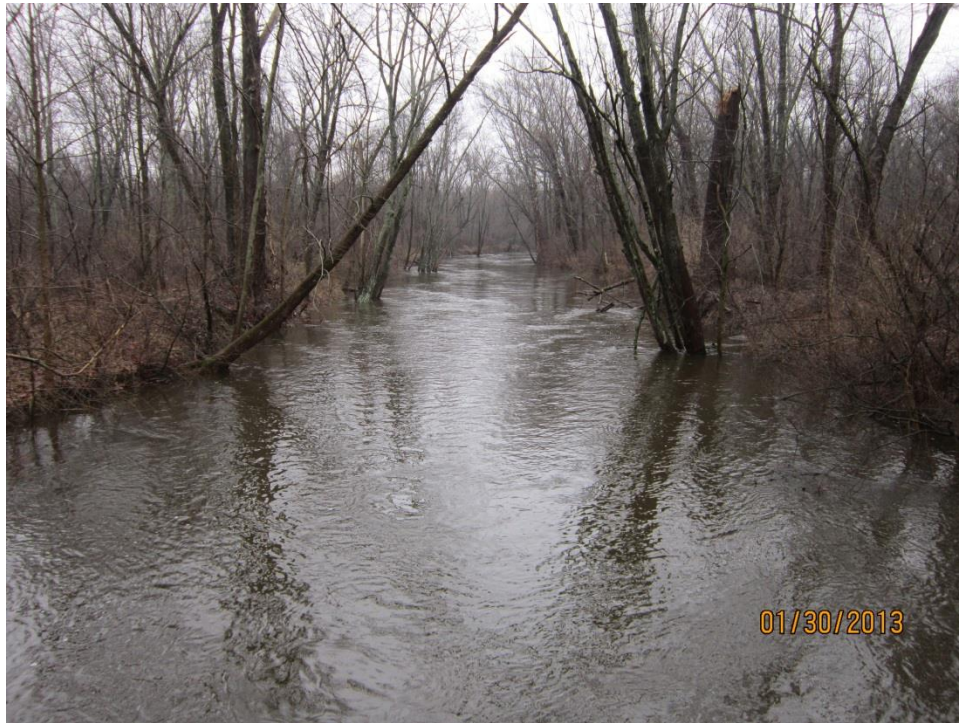
Figure 26. The Dowagiac River features long, straight, homogeneous channel reaches bordered by vegetated berms (dredge spoils).

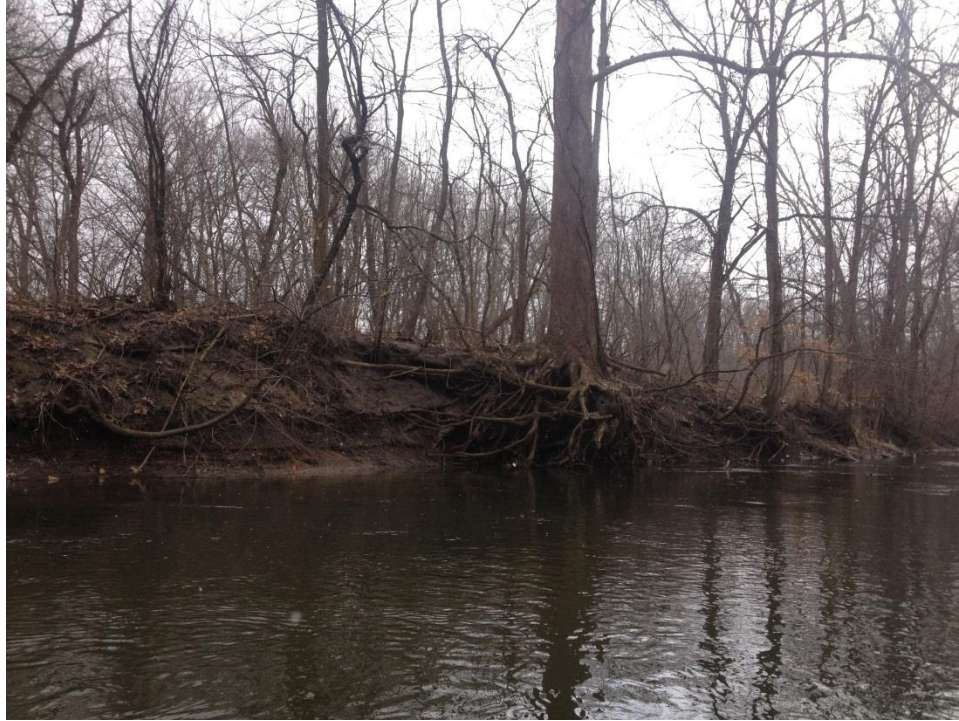
Figure 28. Typical erosion and woody debris along the Dowagiac River banks.

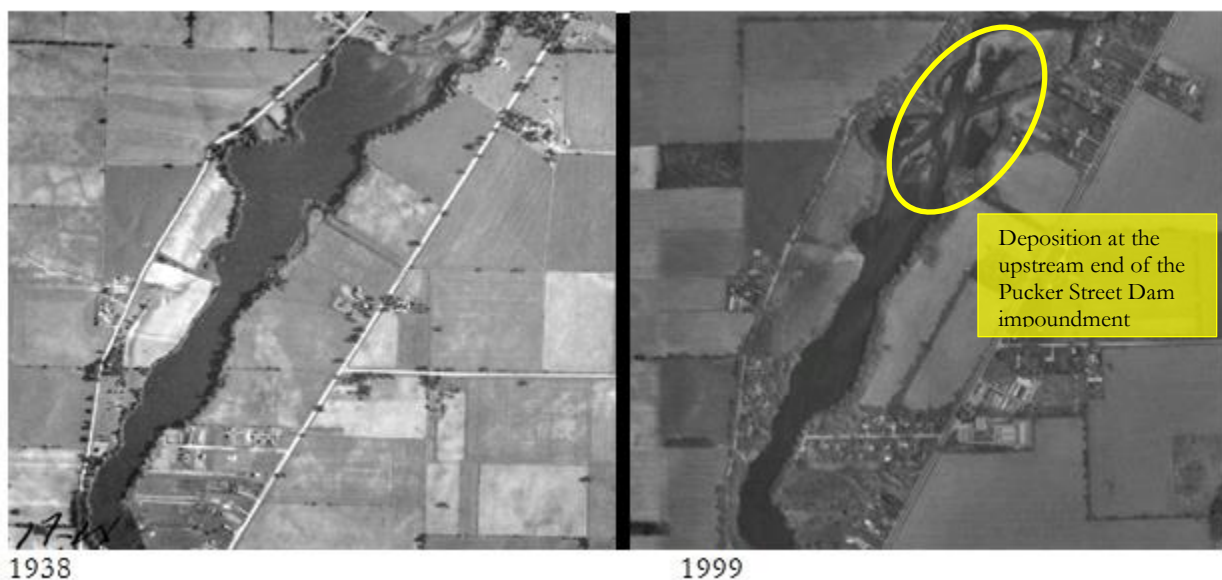
Figure 45. Comparison of the 1999 air photo and 1938 air photo at the Pucker Street Dam impoundment. A sizeable delta formed over the northern (top of figure) third of the reach.

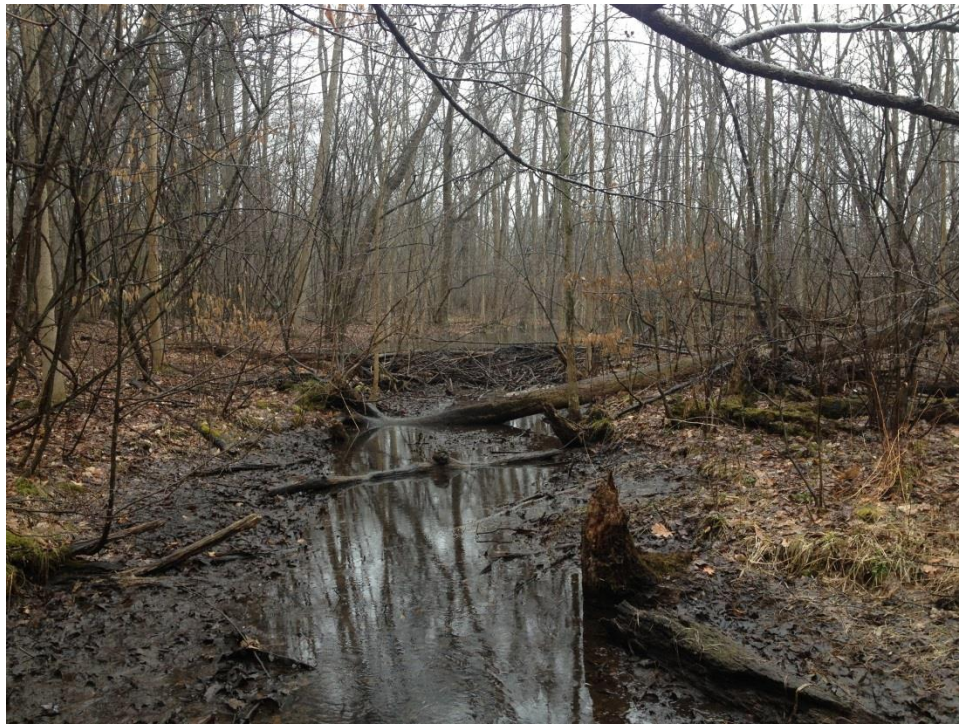
Figure 48. Beaver dam just below Rodgers Lake

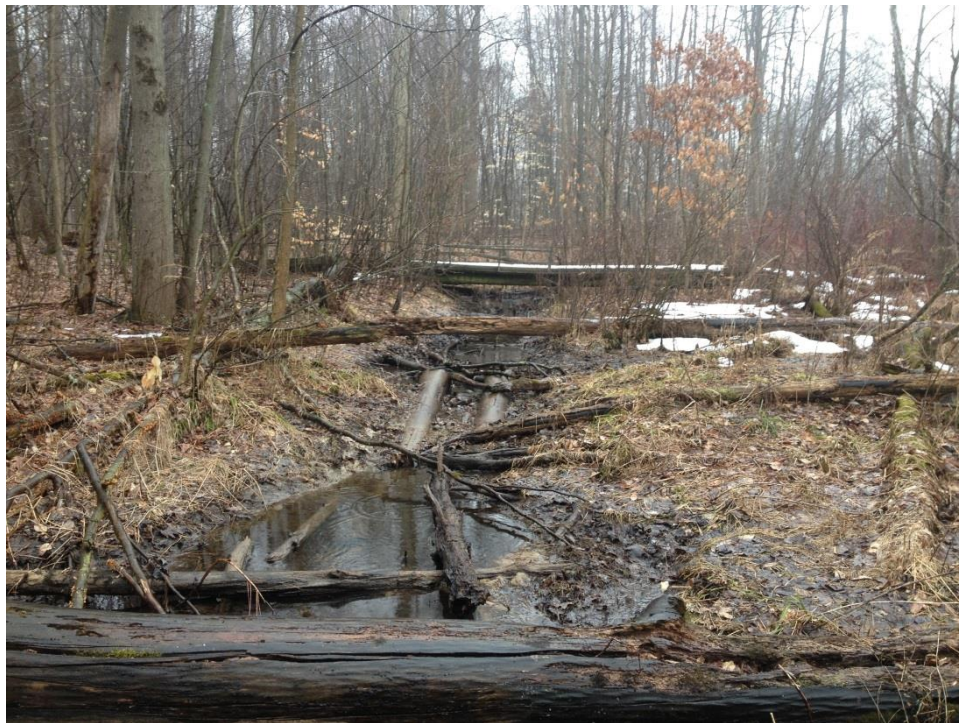
Figure 50. The old crossing above the pond - note the two old pipes in the bed

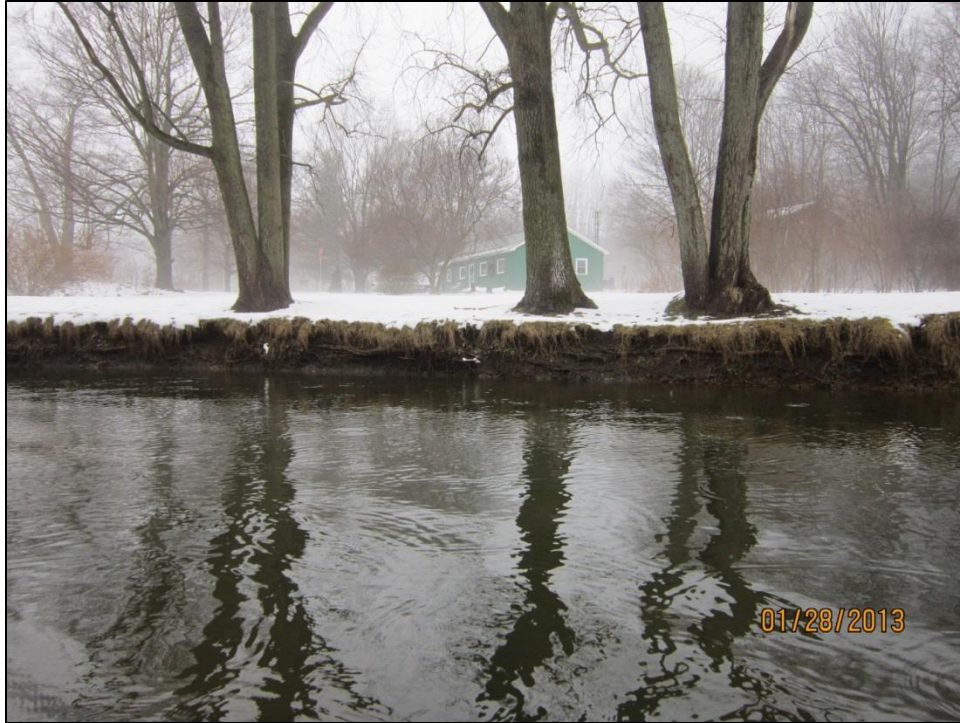
Figure 65. Photo looking west from the river at the home just upstream of Peavine St. There is little freeboard for the house in the background.
