Dowagiac River Restoration

Final Assessment Report

June 27, 2013

**DOWAGIAC RIVER ASSESSMENT
FINAL REPORT**

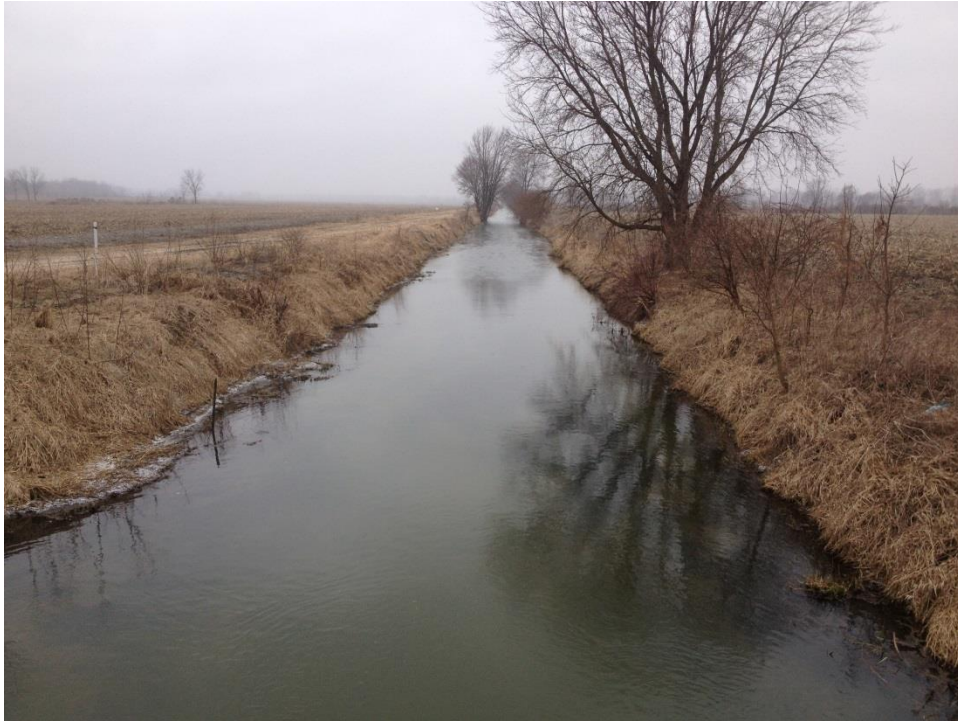
Figure 8. Photo of the channelized portion of the Dowagiac River near Decatur. One can imagine a lake bed here, bounded between the two moraines on the left and right.

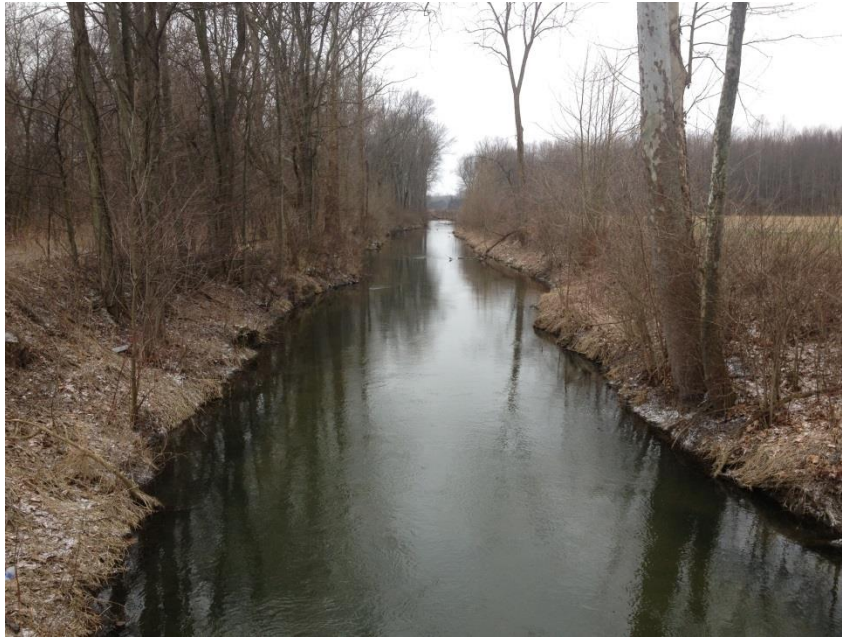
Twin Lakes Rd. Bridge – Trees continue in this section, the channel appears to gain some width here and the adjacent landscape indicates a transition out of the swamps of the upper watershed. The bed is largely sand and fines with no gravels apparent. Bank height begins to increase slightly.

Figure 17: Twin Lakes Rd. - trees and banks indicate a stable channel section. Periodic dredging may still occur here, evidenced by the lack of trees along the right bank in the photo

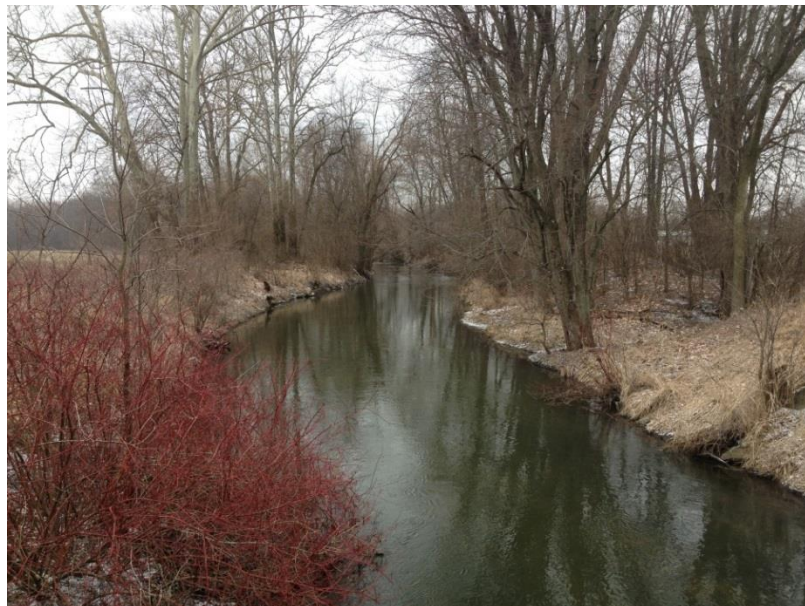
At Dewey Lake Rd. Bridge – A slight floodplain is evident here in the photograph as well as a slight bend – may indicate a location where the old channel and the excavated channel were coincident. Overall similar observations, stable channel, a bed of sands and fines. If there were significant sediment coming in from upstream a small deposit might be expected along the right bank in the photo below.

Figure 18: Dowagiac River at Dewey Lake Rd.

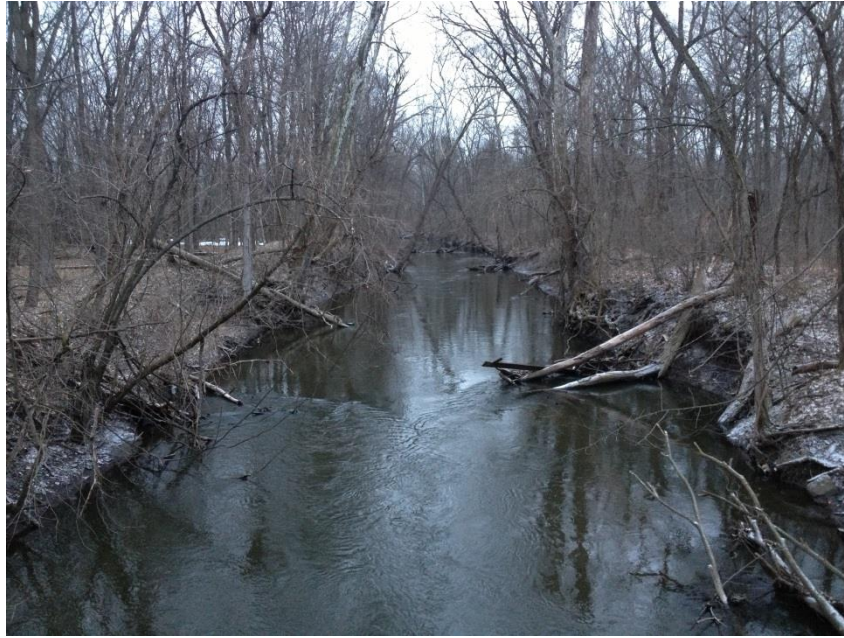
At Middle Crossing Rd. – This sections appears to be slightly more active than others, although it must be noted that this observation is specific to the area around the bridge. Trees are more common in the channel and the dimensions appear consistent with what was observed upstream. Some bank erosion is noted in the right of the photo, the first significant erosion noted, but localized and likely due to scour from trees. The levees on either side persist, though have been removed by landowners where houses are present. A small tributary enters here from the west, draining cultivated land. In the photos the contribution of sediment from this tributary is higher than normal, but this scenario appears to be infrequent within the watershed.

Figure 21: Dowagiac mainstem at Indian Lake Rd.
